# ORION ENVIRO MARINE SERVICE PROVIDES HAZARDOUS MATERIAL SERVICES USING COMPUTED RADIOGRAPHY

*Orion Enviro Marine Services (OEMS) in Freeport, Bahamas was founded in 2014 and they are a leading provider of hazardous material services for marine insurers, shipping lines, pharmaceutical manufacturers, industrial contractors, and ship repairs.*

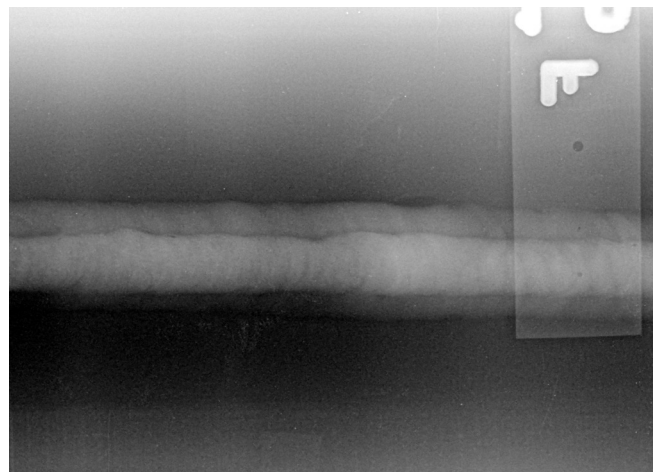
The wall thickness of the tanks and attachments varied quite a bit creating differences in densities within the radiograph. The first image on the left was made on one of the tanks near a nozzle using an 80 Ci Ir-192 source. There were two separate regions of interest in this image. One was of the seam weld on the tank and the other was of the nozzle weld. Using the powerful image adjustment tools built into the software, it was possible to focus on the different density areas of the tank without using multiple exposures, as would typically be necessary with film radiography. There was also an area where some linear indications were present. Using the magnification tool it was possible to magnify the area to better evaluate the discontinuity which would not have been possible with film radiography.

project where they were asked to perform radiographic inspection on the primary containment welds on pressure vessels. The buildings at the factory where the pressure vessels reside took a direct hit when category 5 hurricane Dorian struck on August 24th, 2019. Wind speeds reached a maximum of 296 km/h and caused heavy damage to the buildings and some of the equipment inside. Before these pressure vessels could be used again 100% of the circumferential and attachment welds had to be visually and radiographically inspected to ensure their integrity.
